**Research-Scale Fire Performance Evaluation
of a Wood Floor Joist/Tin Ceiling Panel
Assembly**

***ASTM E119-98: Standard Test Methods for
Fire Tests of Building Construction and
Materials ****

*** Research-scale horizontal test, modified in that the sample size
was less than 180 ft² (16 ft²) and no load was applied**

WFCi Report #04042(b)

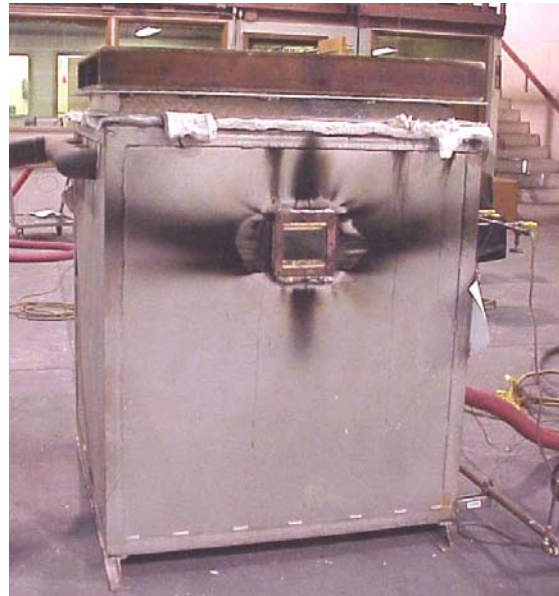
FIGURE 1: HORIZONTAL FURNACE

The furnace used in the test is a small-scale fire burning apparatus, fueled by natural gas (pictured at right.) The sample was mounted on to the top of the furnace horizontally. The exposed surface is subjected to the time-temperature curve, while temperature measurements are taken from the unexposed surface, using a computerized data acquisition system.

The furnace valves are controlled based upon the average of the interior furnace temperature, which is determined from the internal thermocouples. Additional thermocouples are added to the unexposed surface of the specimen to monitor the specimen's temperature. Windows are provided in the sides of the furnace to allow viewing of the specimen's exposed surface and the taking of photographs during testing. Upon completion, or early termination of a test, the main gas supply valve is closed and the specimen is removed from the furnace, allowing for hose stream testing of specimen, if applicable, and allowing for post-testing observations.

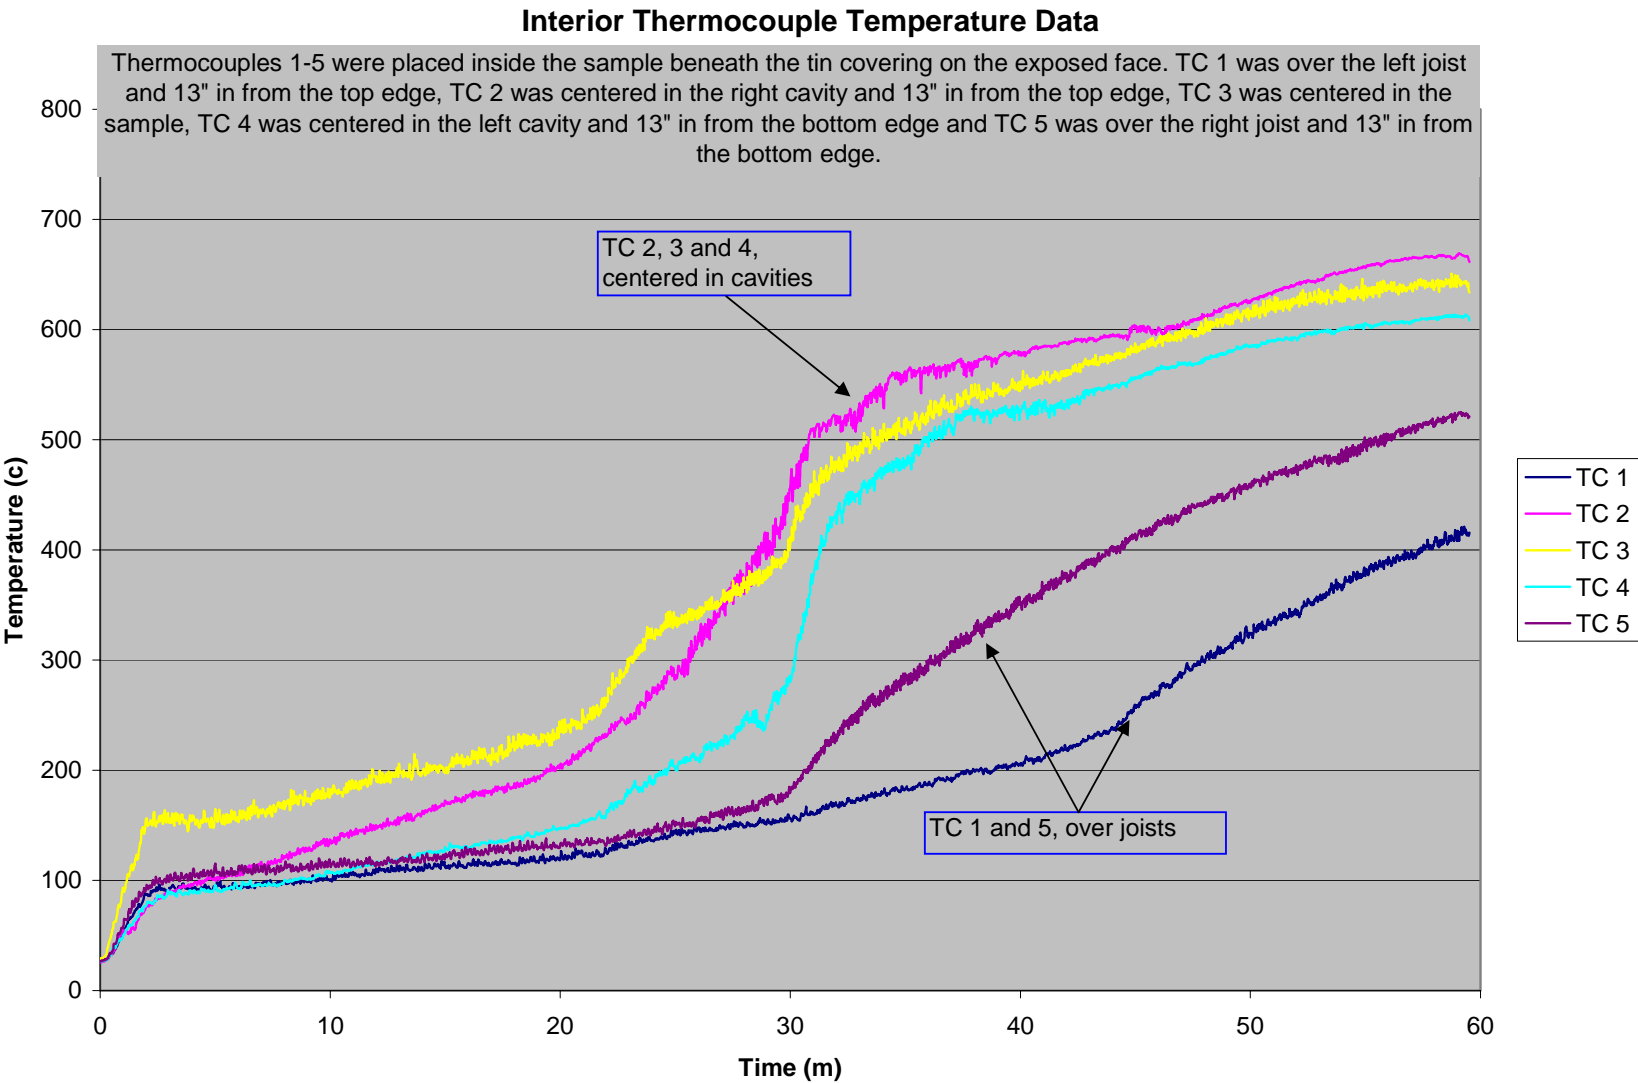
Chart 2: Interior Thermocouple Temperatures

Time	Temperature (Celsius)				
	TC1	TC2	TC3	TC4	TC5
0:00:00	28.4	26.0	28.9	26.7	26.8
0:05:00	92.7	99.6	163.0	94.9	114.0
0:10:00	101.0	136.7	178.8	107.1	113.3
0:15:00	111.5	171.6	200.5	130.0	123.9
0:20:00	120.9	205.8	236.5	147.3	133.6
0:25:00	145.1	286.3	336.5	200.2	153.0
0:30:00	156.2	462.4	411.6	282.5	181.4
0:35:00	183.1	558.9	508.2	478.8	282.8
0:40:00	204.8	579.6	553.2	525.7	351.9
0:45:00	257.3	602.2	583.8	555.5	409.8
0:50:00	324.6	626.2	616.9	585.0	456.6
0:55:00	378.3	656.2	638.0	605.7	494.4
0:60:00	415.7	661.4	633.6	608.4	521.1

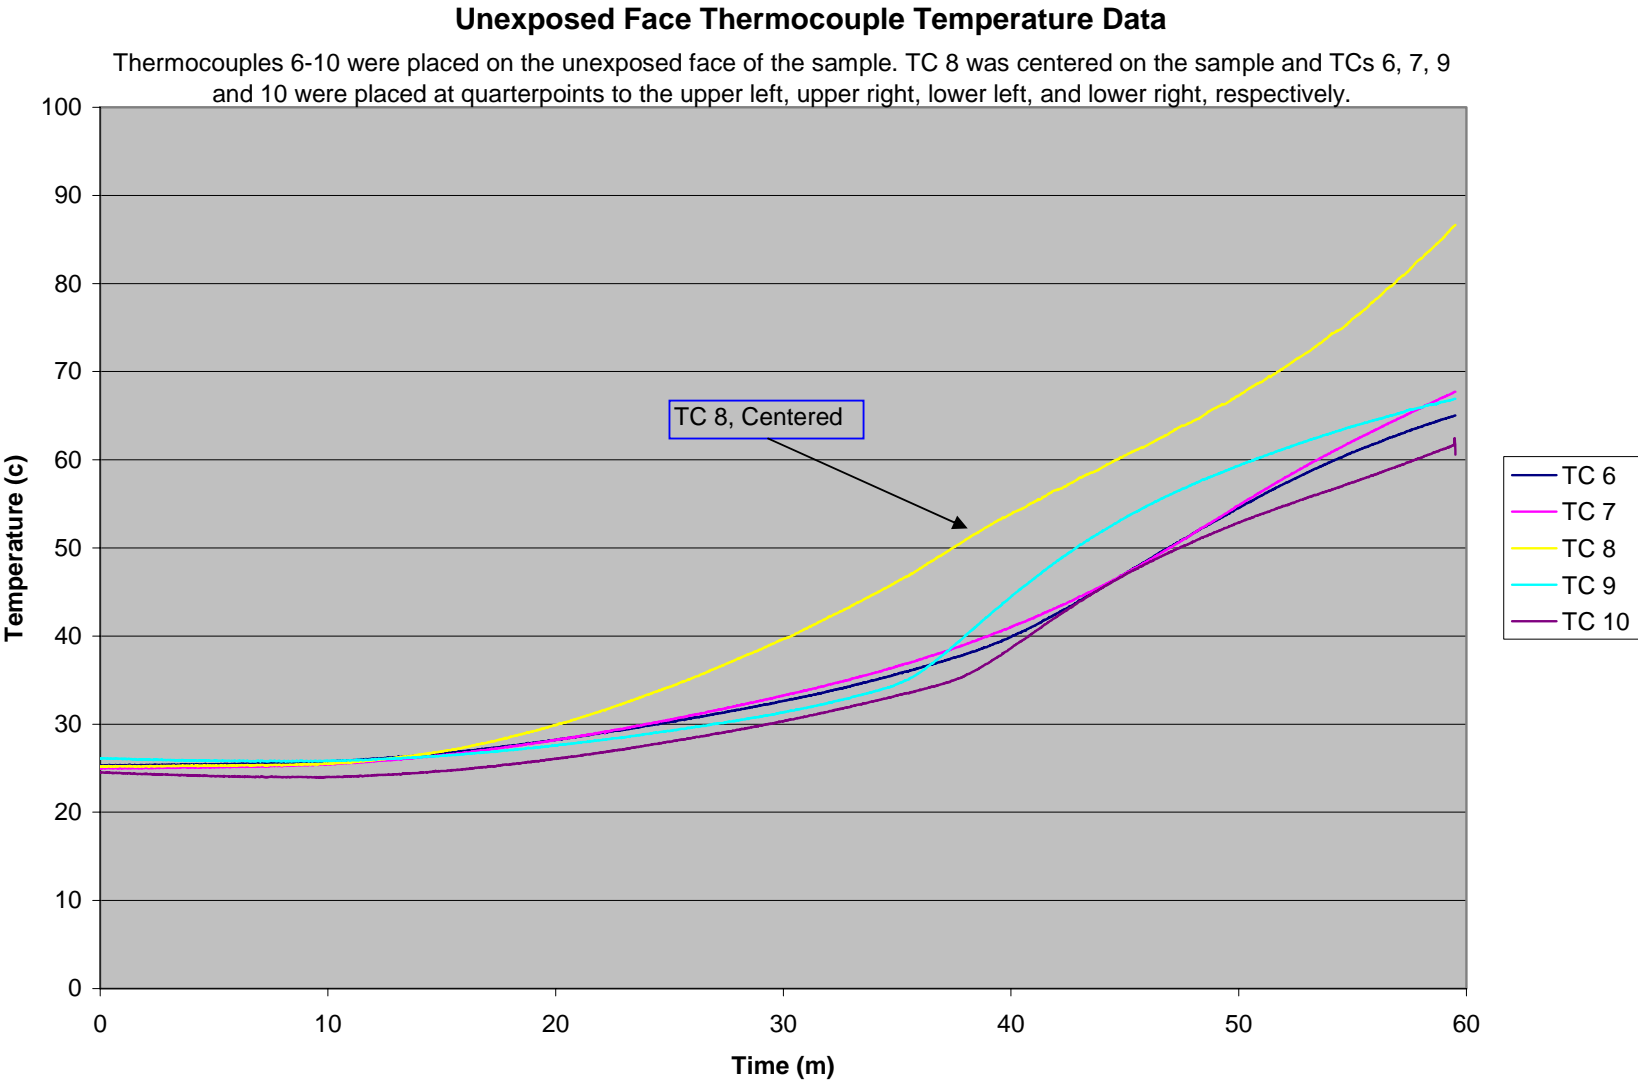
Chart 3: Unexposed Thermocouple Temperatures

Time	Temperature (Celsius)				
	TC6	TC7	TC8	TC9	TC10
0:00:00	25.3	25.0	25.2	26.1	24.5
0:05:00	25.4	25.1	25.3	25.8	24.1
0:10:00	25.8	25.4	25.5	25.8	24.0
0:15:00	26.7	26.5	26.9	26.4	24.7
0:20:00	28.2	28.2	29.9	27.6	26.0
0:25:00	30.2	30.5	34.2	29.2	28.0
0:30:00	32.6	33.3	39.7	31.3	30.3
0:35:00	35.7	36.5	46.2	34.6	33.3
0:40:00	39.9	41.1	53.9	44.5	38.7
0:45:00	47.1	47.1	60.5	53.4	47.0
0:50:00	54.6	54.9	67.3	59.3	52.9
0:55:00	60.9	62.1	76.0	63.8	57.5
0:60:00	65.0	67.7	86.7	66.9	60.6

The 4' X 4' fire-retardant coated tin ceiling/wood floor joist assembly described in this report successfully withstood a 1 hour fire endurance period in this research-scale test. Temperatures on the unexposed side of the assembly remained below failure limits (with thermocouple 8 peaking at below 90°C) and no flaming occurred on the unexposed side during the test. The load-bearing capability of this assembly was not assessed in this test.

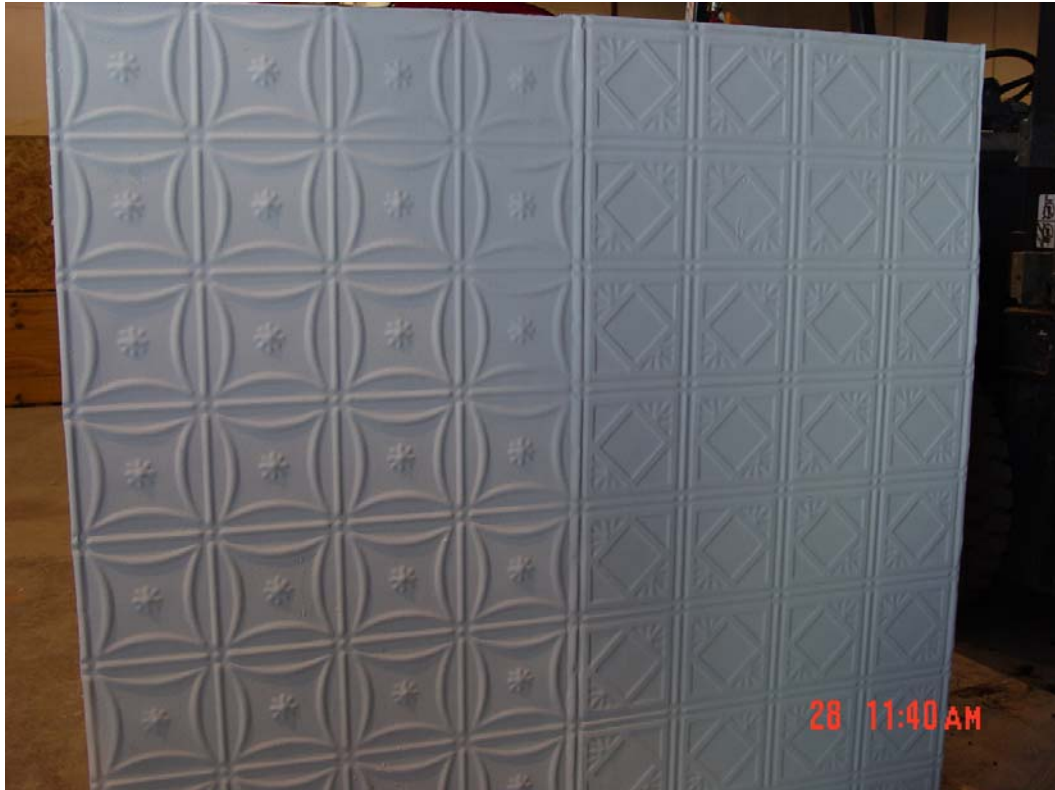
Photograph 1: Exposed face of sample, pre-test

The 4' X 4' ceiling/floor joist assembly was constructed of rough cut (full dimensional) Douglas fir 2"X10" wood joists spaced at 16" on center to simulate a flooring section of an older building. The exposed face of the sample was covered with two 2' X 4' tin ceiling panels which were then coated with Red Primer 15X0505 487 water-based primer, followed by 40 mils of sprayed-on intumescent material, identified as ALBI-TF. The unexposed side was covered with 1"x4" fir tongue and groove subfloor under 5/8" CDX plywood decking.

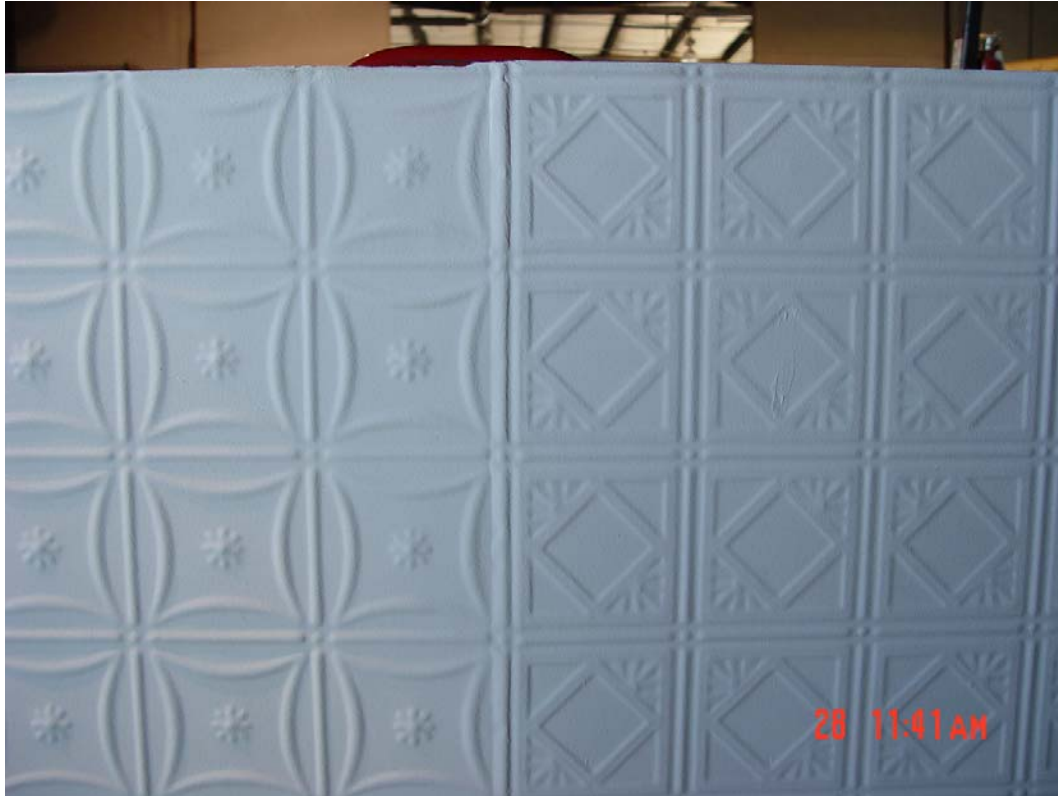
Photograph 2: Closer view of sample exposed face

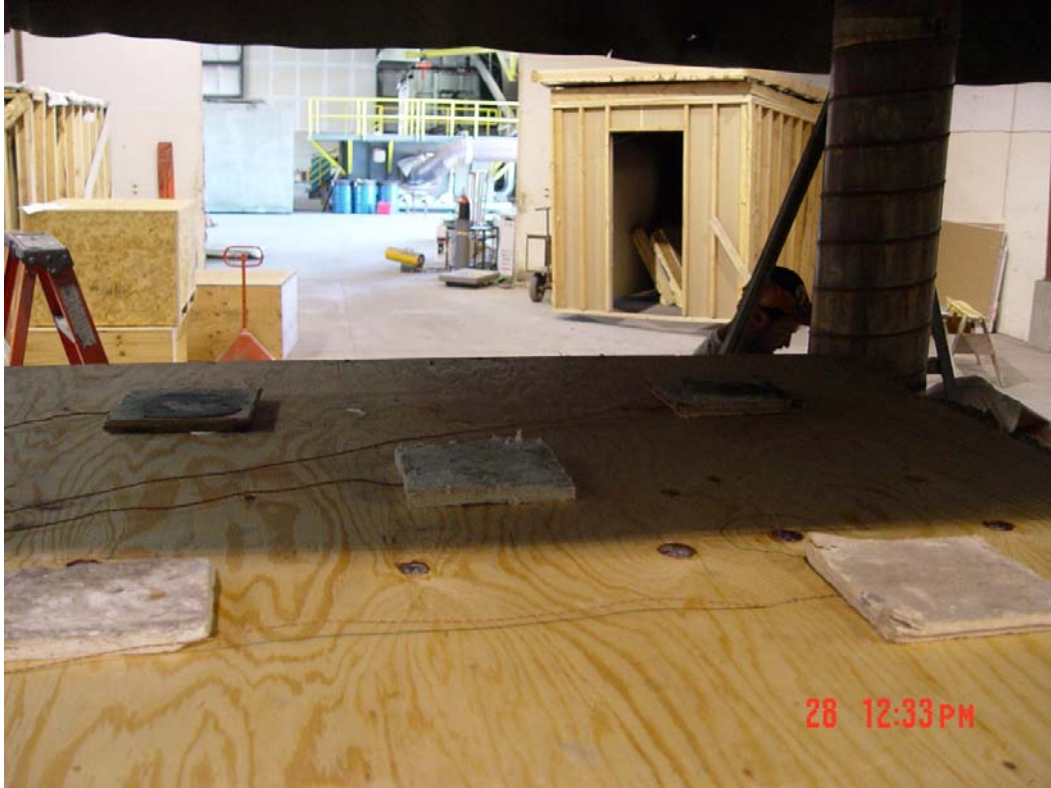
Photograph 3: Unexposed sample face pre-test showing thermocouple placement

Thermocouples 6-10 were located on the unexposed face of the wall construction. TC 8 was centered on the sample and TCs 6, 7, 9 and 10 were placed at quarter points on the upper left, upper right, lower left and lower right corners of the sample, respectively.

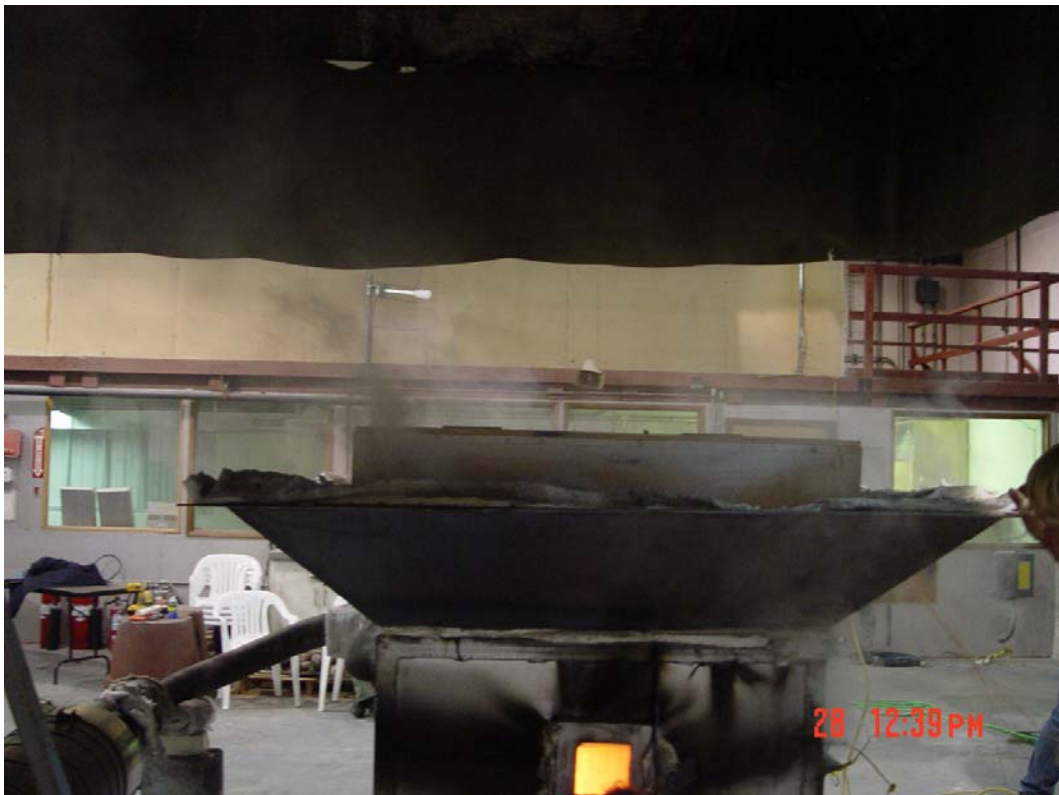
Photograph 4: Smoke rising from the sample early in the test

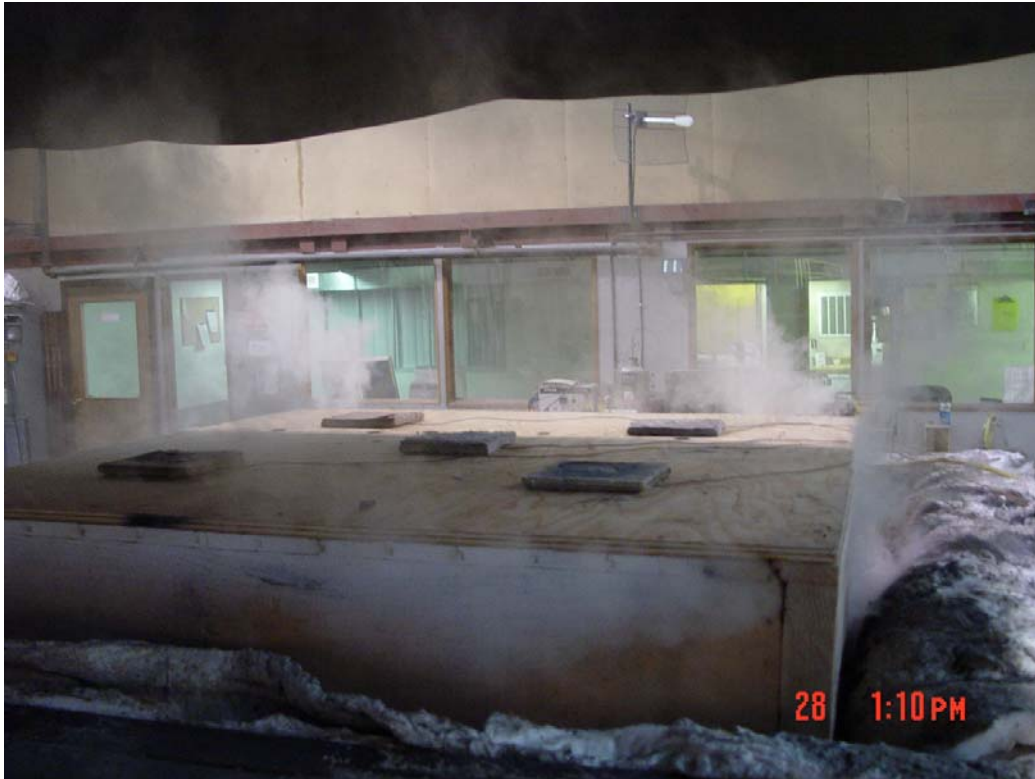
Photograph 7: Unexposed face of the sample during test

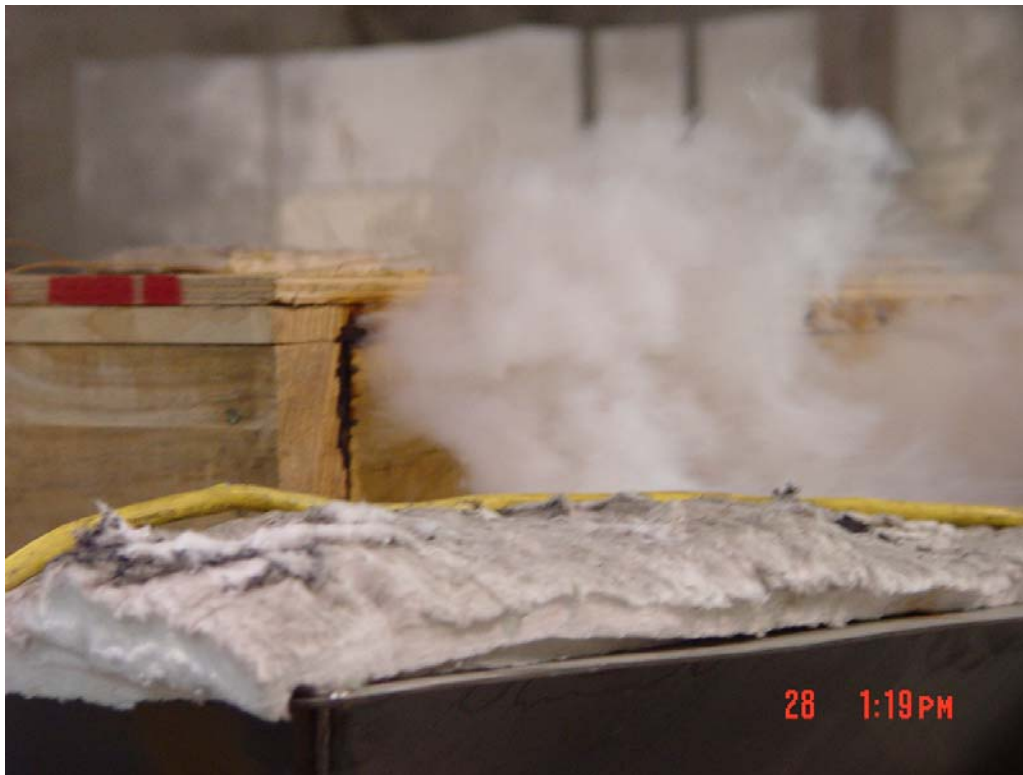
Photograph 8: Smoke shooting from a gap in the frame of the sample

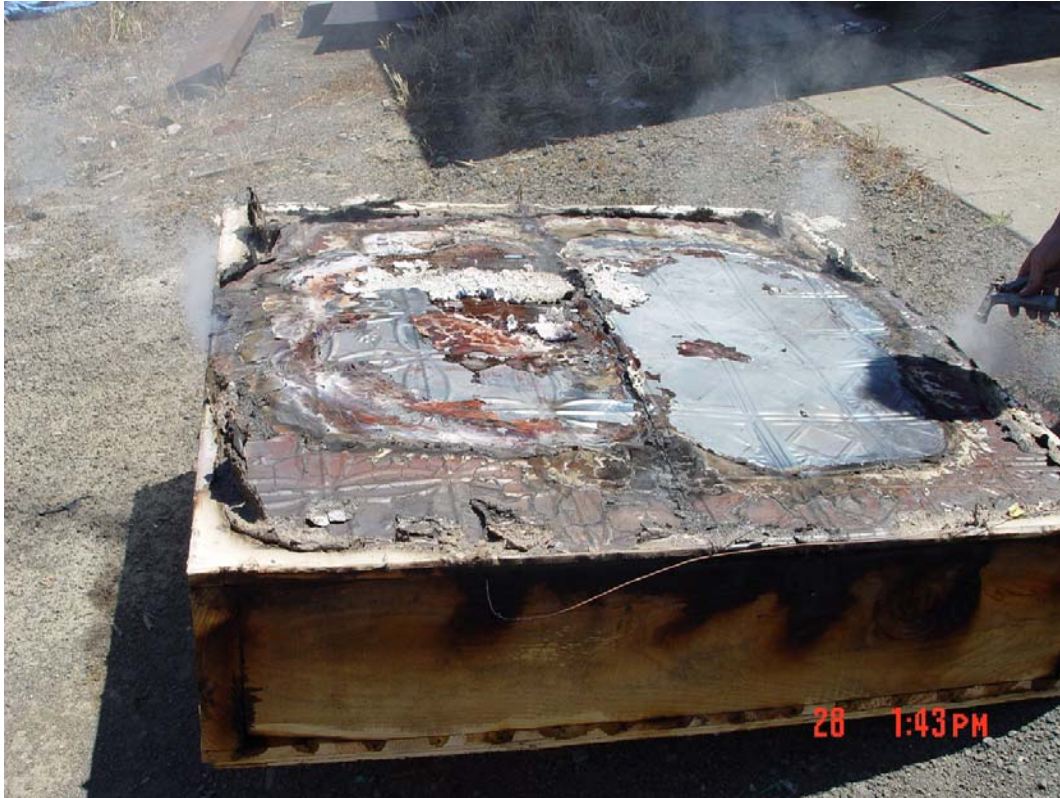
Photograph 9: Exposed face of the sample post-test

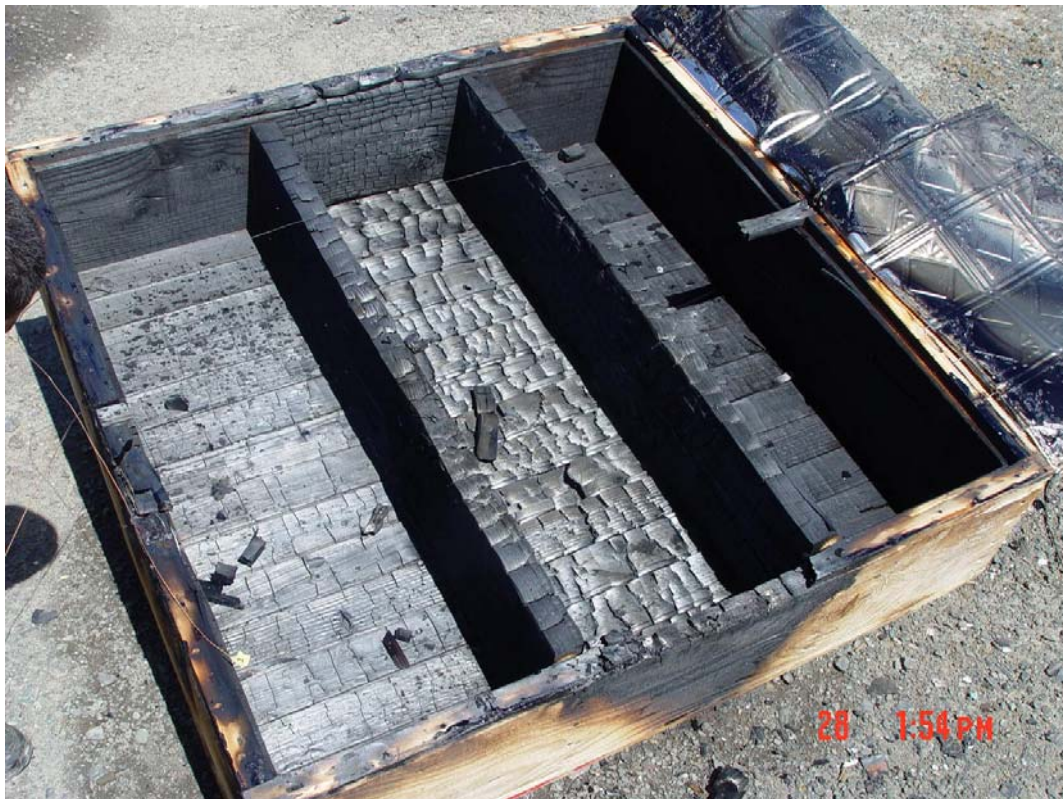
Photograph 10: Interior of sample post-test

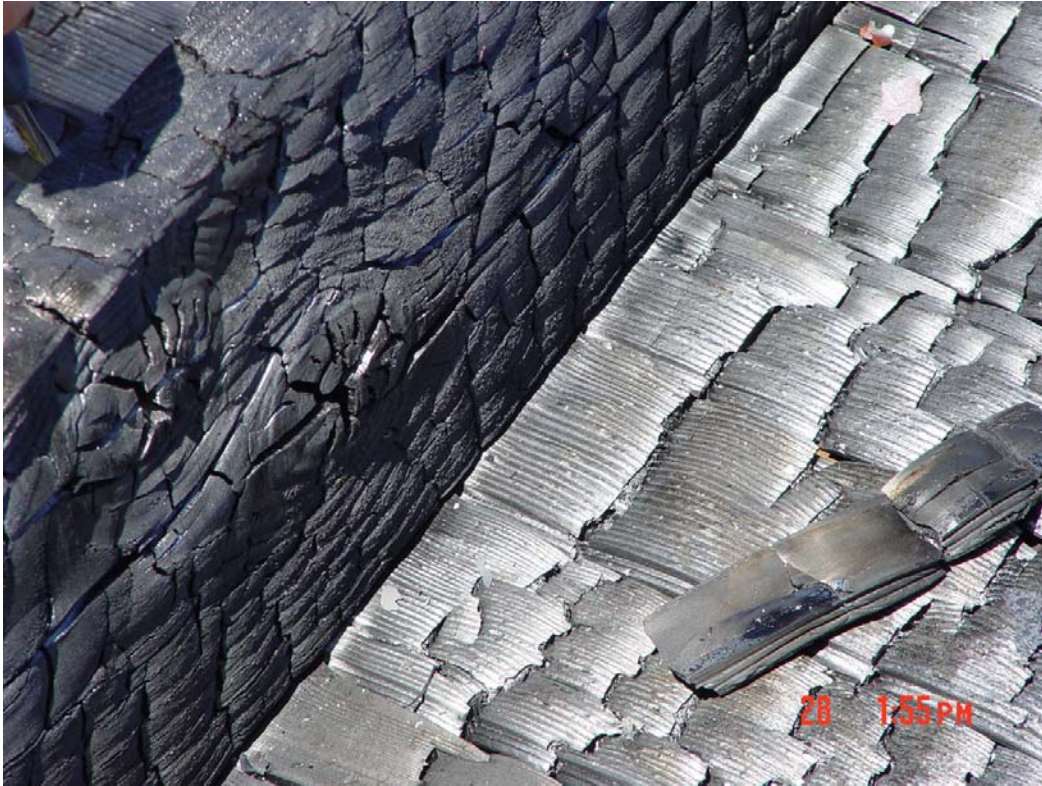
Photograph 11: Close-up of sample interior post-test

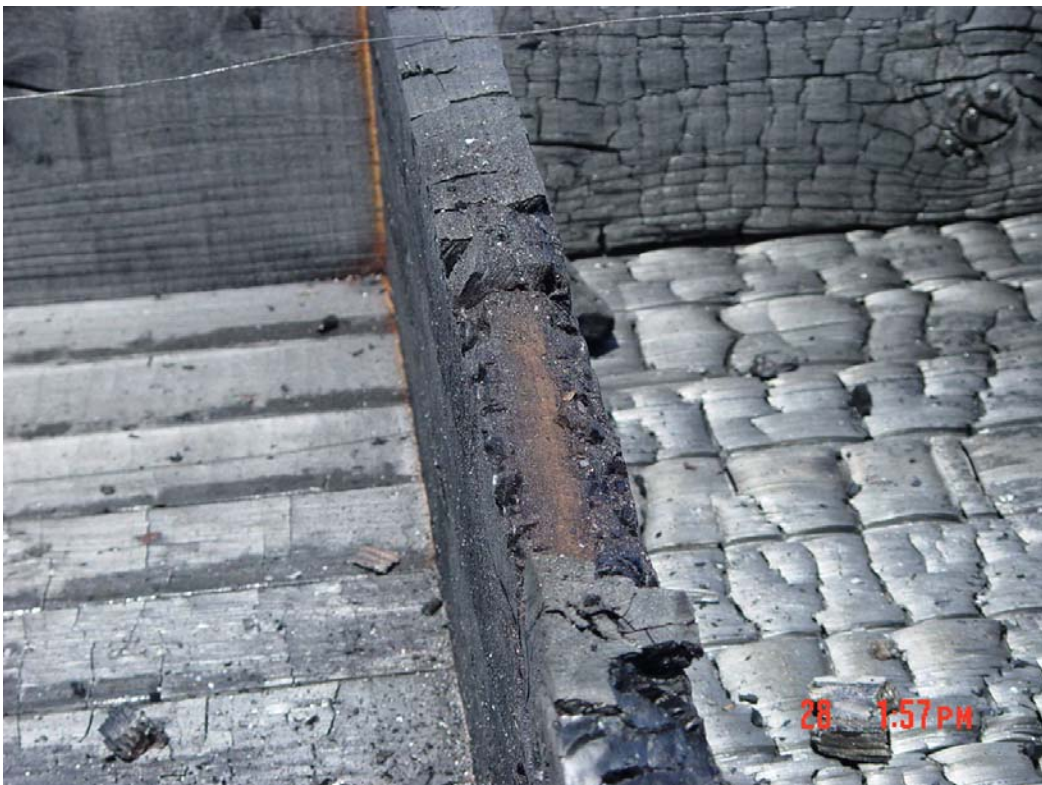
Photograph 12: Close-up of exposed joist with char scraped away
