Western Fire Center, Inc.

**Research-Scale Fire Performance Evaluation
of an FR-Coated Gypsum Wallboard/ Wood
Stud Wall Construction**

***ASTM E119-98: Standard Test Methods for
Fire Tests of Building Construction and
Materials****

WFCi Report #04042(d)

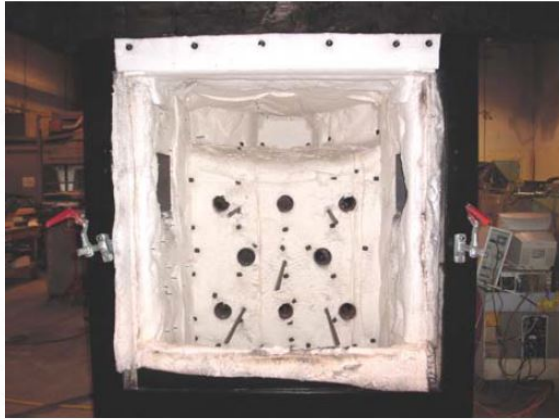
Figure 1: Small-Scale Vertical Furnace Front View

The furnace used in the test is a small-scale fire burning apparatus (Figures 1 & 2), fueled by natural gas. The test assembly was mounted onto a steel frame specimen holder and installed into the furnace vertically. The exposed surface was subjected to the time-temperature curve, with temperature measurements taken inside the furnace using thermocouples connected to a computerized data acquisition system. The furnace valves are controlled based upon the average of the interior furnace temperature that is determined from these five internal thermocouples. Windows allow viewing of the specimen surface and the taking of photographs during testing. Upon completion, or early termination of a test, the main gas supply valve is closed and the specimen frame is unlatched from the furnace, allowing for extinguishment of specimen, if applicable, and allowing for post-testing observations.

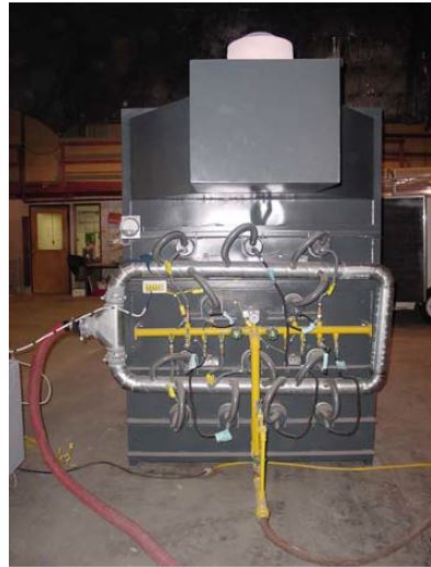
Figure 2: Small Scale Vertical Furnace Rear View

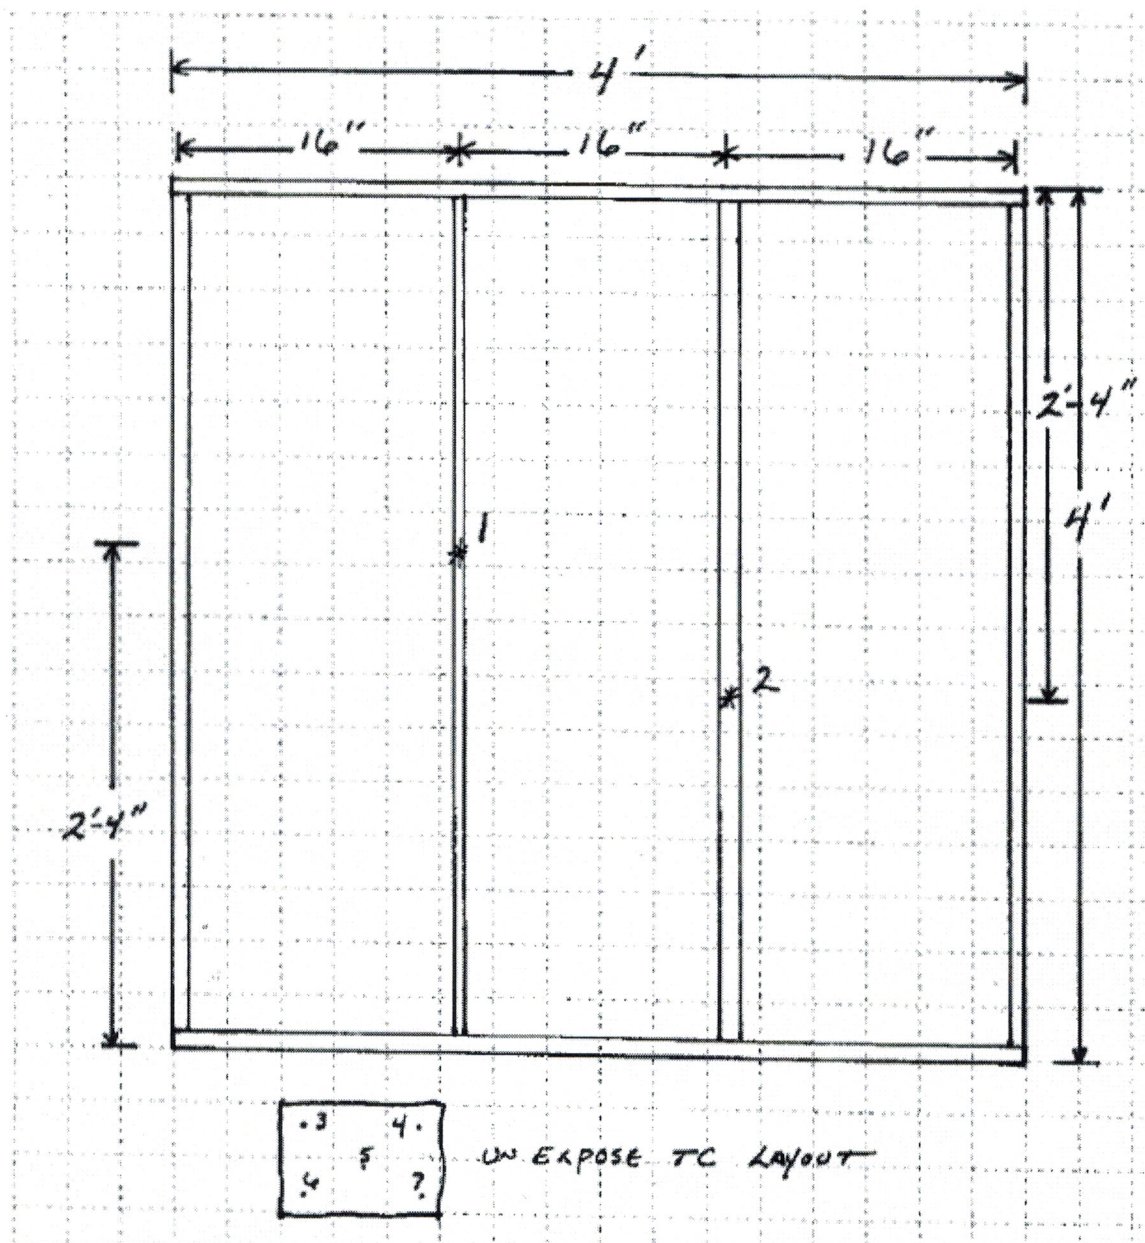
Diagram 1: Sample Layout

Seven thermocouples were placed on the sample to record temperatures during the test. Two of these thermocouples, TCs 1 and 2, were placed inside the sample between the wood studs and the exposed gypsum layer. TC 1 was on the left stud (facing the exposed side), 2'-4" up from the bottom of the sample, and TC 2 was on the right stud 2'-4" down from the top of the sample. TCs 3-7 were on the unexposed face of the sample with TC 5 in the center 2' from each edge and the rest in corners 12" from each of the nearest two edges. TC 3 was in the top left corner (facing the unexposed sample face), TC 4 in the top right corner, TC 6 in the bottom left and TC 7 in the bottom right corner.

The sample in this test was a 4'X4' wood framed 2"X4" construction with the exposed and unexposed sides sheathed with 5/8" Fireguard GP ToughRock type X gypsum wallboard. The studs in the construction were spaced at 16" on center. The exposed surface was coated by the client's representative with Red 15X0505 487 water base primer and 60 mils of Albi Clad TF intumescent coating.

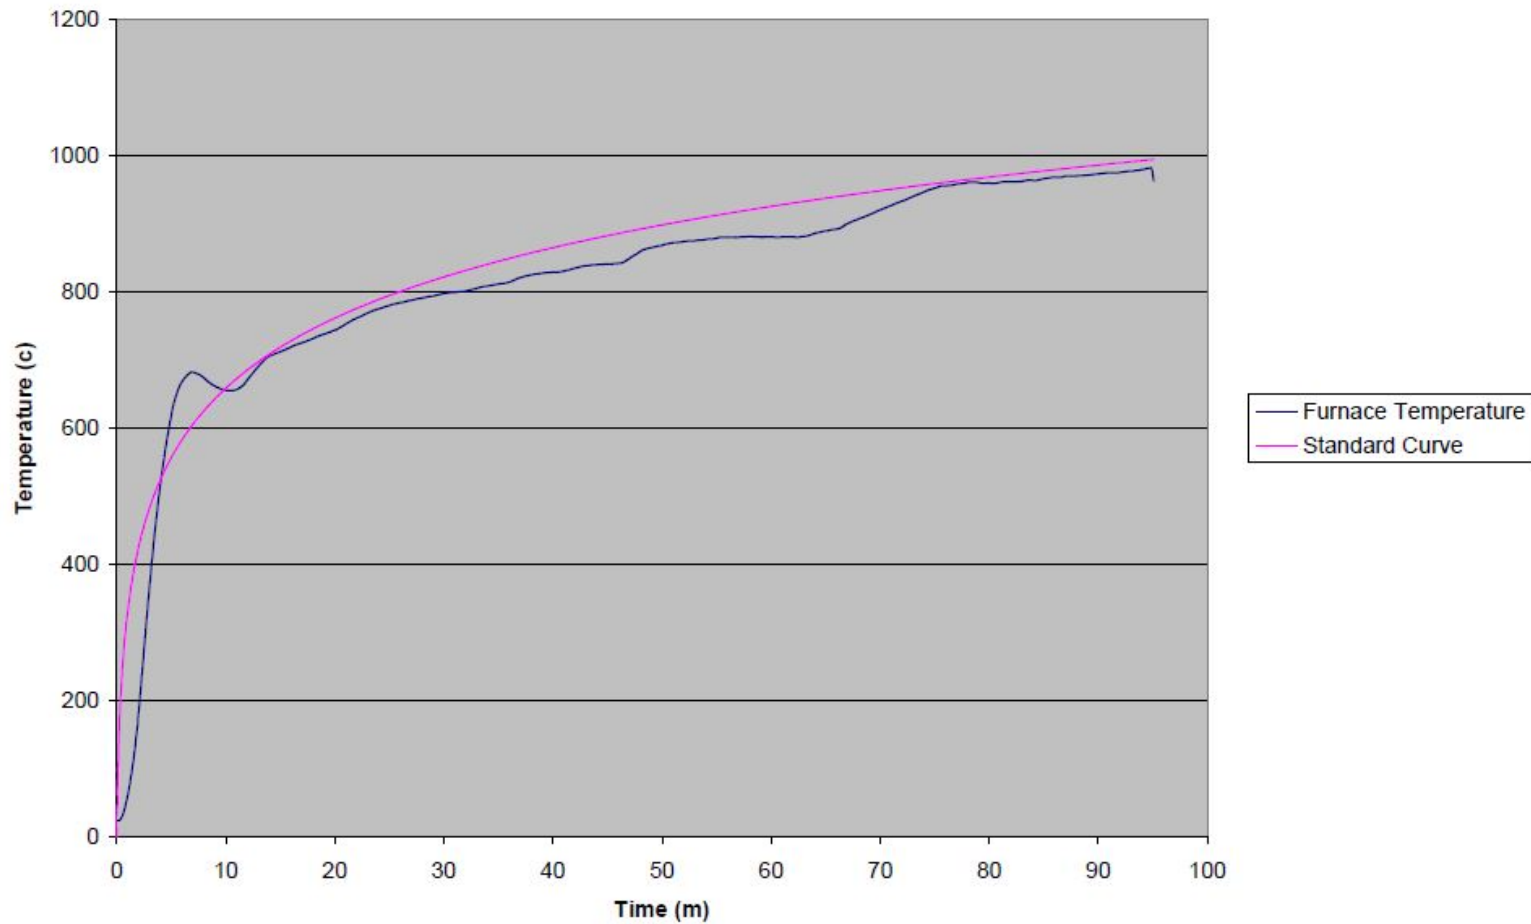
Chart 1: Furnace Temperature Vs. Standard Curve

Furnace Temperature Vs. Standard Curve

Time	Total % of Standard Curve	Temperature (Celsius)	Standard Temperature
0:00:00	0	0	0
0:05:00	83.4	618.8	556.8
0:10:00	102.6	655.3	658.6
0:15:00	100.3	712.1	718.7
0:20:00	99.3	743.8	761.5
0:25:00	98.9	780.0	794.7
0:30:00	98.4	797.7	821.9
0:35:00	97.9	811.4	844.9
0:40:00	97.4	828.8	864.8
0:45:00	97.0	840.8	882.4
0:50:00	96.8	868.2	898.1
0:55:00	96.7	878.7	912.4
1:00:00	96.6	880.5	925.4
1:05:00	96.3	889.5	937.3
1:10:00	96.2	920.3	948.4
1:15:00	96.5	952.2	958.7
1:20:00	96.9	959.6	968.4
1:25:00	97.1	966.0	977.5
1:30:00	97.3	973.3	986.0
1:35:00	97.5	970.3	994.1

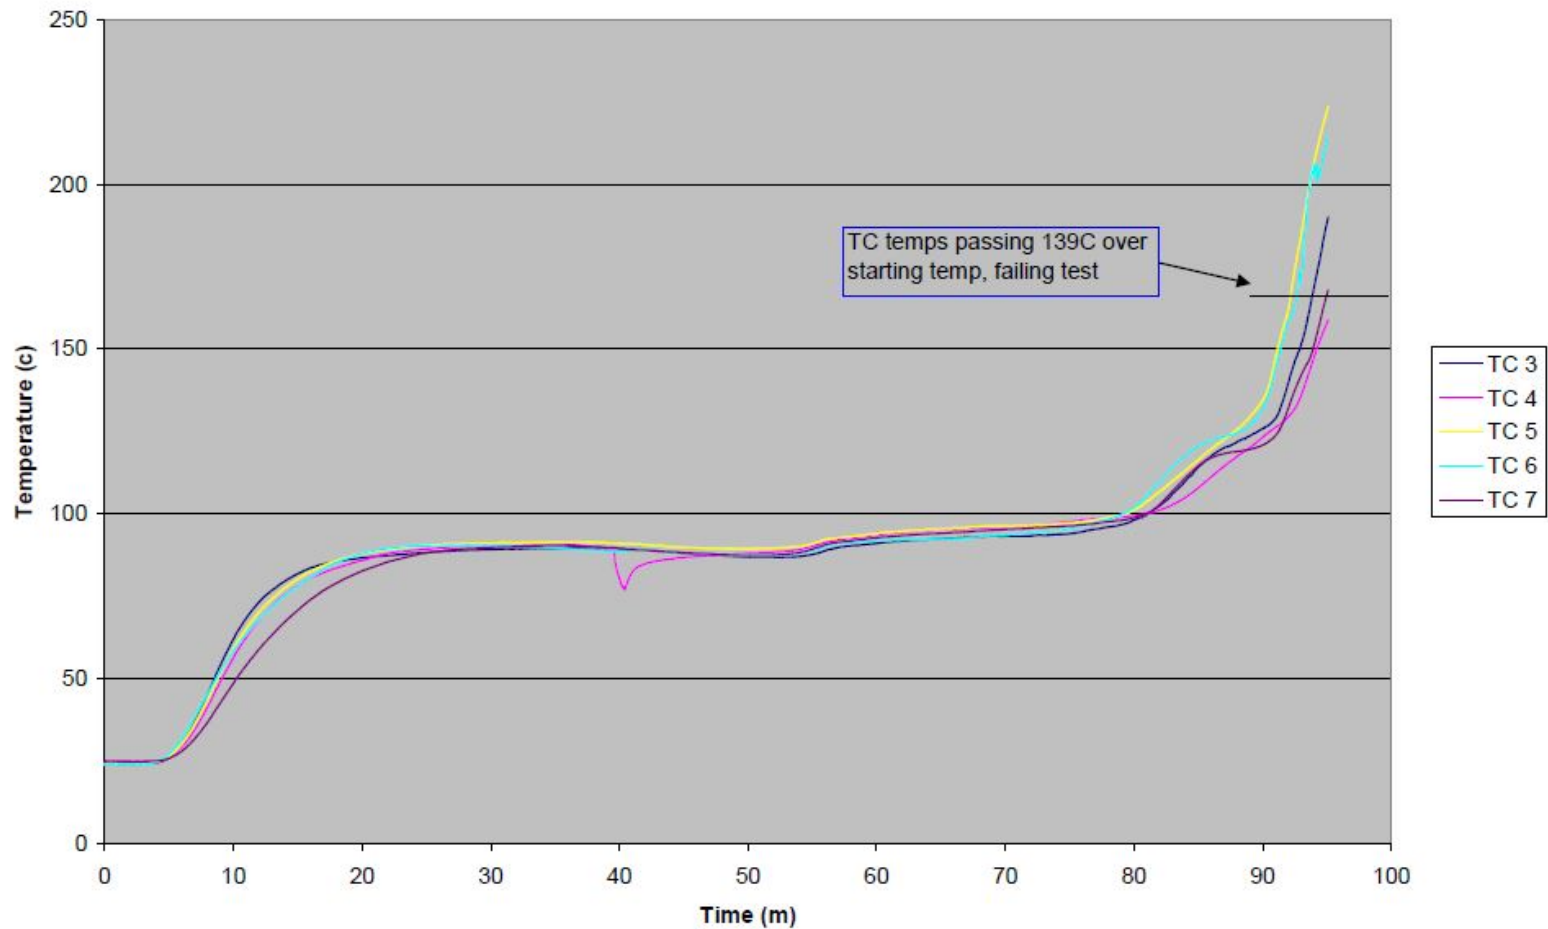
Chart 3: Unexposed Thermocouple Temperatures

Unexposed Face Thermocouple Temperatures

Time	Temperature (Celsius)				
	TC3	TC4	TC5	TC6	TC7
0:00:00	24.3	25.0	24.6	23.9	24.9
0:05:00	26.1	26.3	26.5	27.3	25.9
0:10:00	62.1	56.4	59.1	58.4	48.7
0:15:00	81.8	78.3	80.2	78.1	70.8
0:20:00	86.6	85.8	87.8	87.9	82.6
0:25:00	88.2	89.3	90.3	90.2	88.2
0:30:00	89.2	90.5	91.1	90.4	89.8
0:35:00	89.5	90.9	91.4	89.7	90.3
0:40:00	89.0	80.1	90.9	88.7	89.5
0:45:00	88.1	86.7	89.8	88.2	88.2
0:50:00	86.9	87.9	89.4	87.3	87.3
0:55:00	87.7	90.2	90.9	88.8	89.3
1:00:00	91.0	93.5	94.0	91.8	92.8
1:05:00	92.4	95.2	95.5	92.3	94.1
1:10:00	93.2	96.1	96.3	93.5	95.2
1:15:00	94.0	97.7	97.2	95.5	96.4
1:20:00	98.2	99.3	101.2	102.0	98.8
1:25:00	114.2	108.0	116.4	120.5	114.6
1:30:00	125.8	123.3	134.5	131.9	120.9
1:35:00	188.7	158.1	222.4	213.4	166.9

The initial temperatures on the unexposed surface were approximately 25 degrees C. According to the standard, failure of the sample occurred when the average of the unexposed thermocouple readings reached temperatures higher than 164 C, which occurred slightly after 90 minutes into the test.

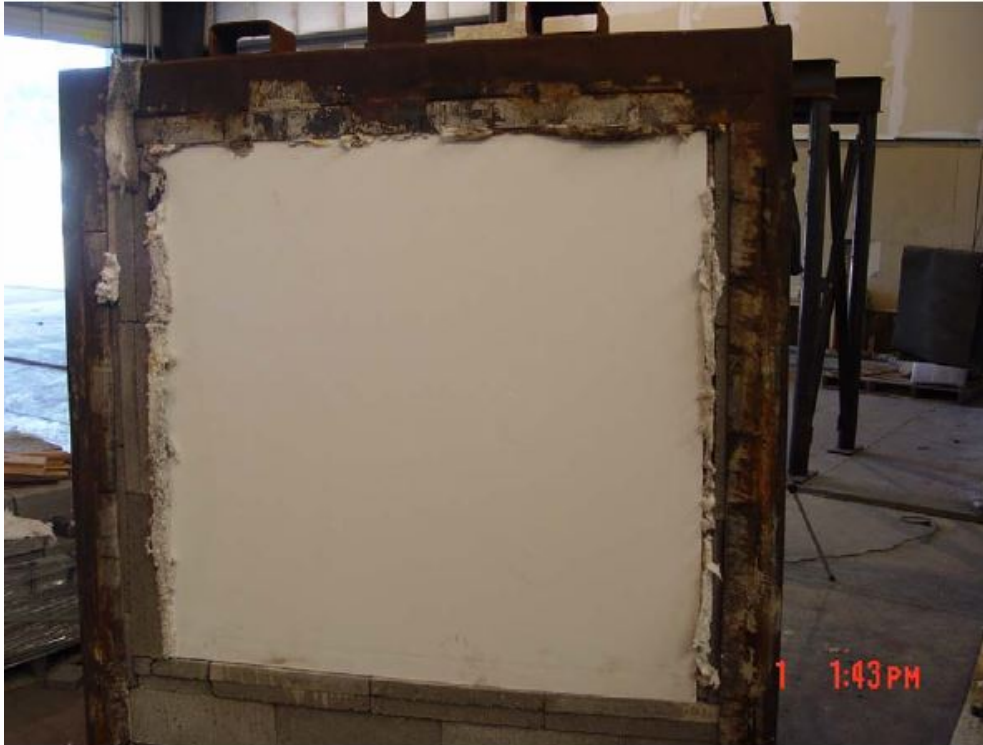
Photograph 1: Sample exposed face pre-test

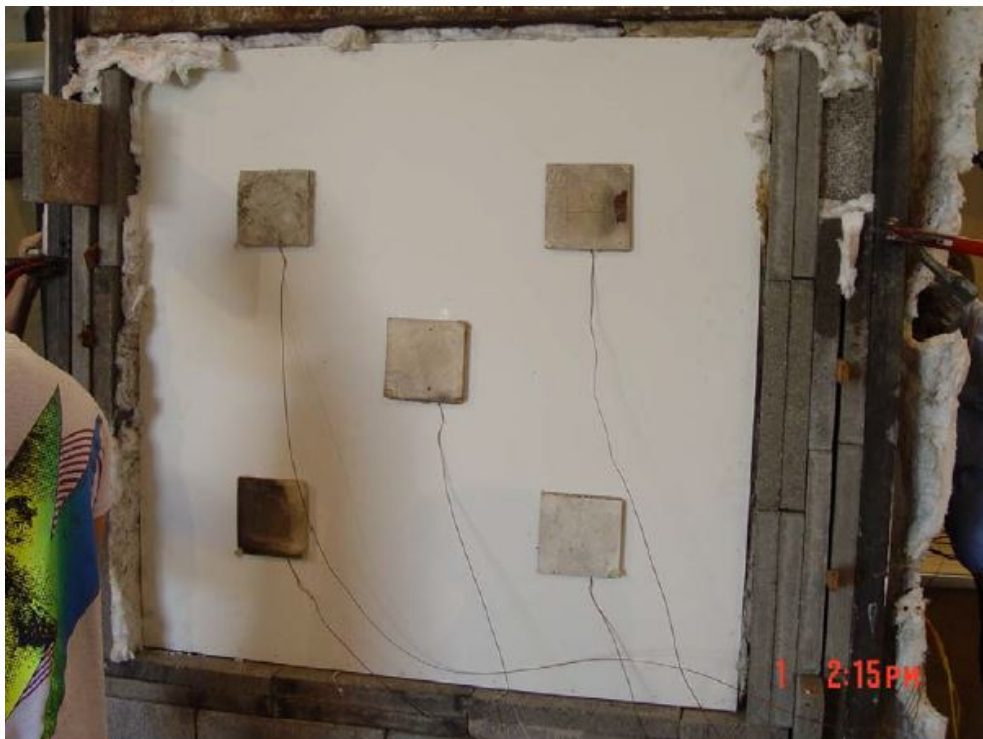
Photograph 2: Sample unexposed face pre-test, showing thermocouples

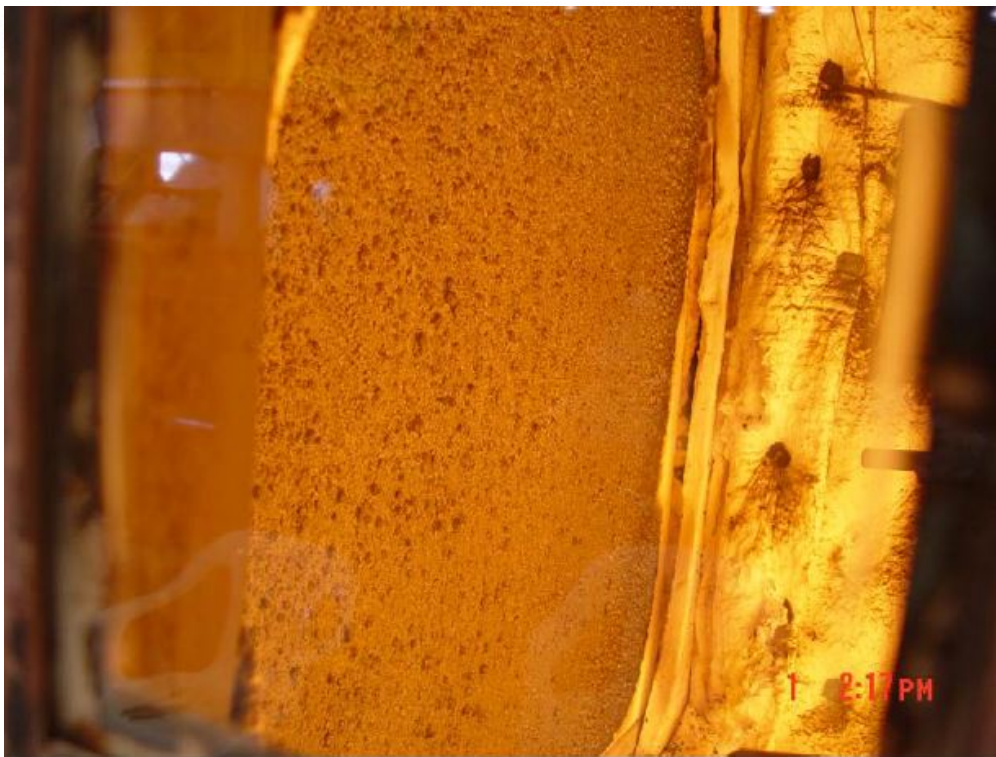
Photograph 3: Sample exposed face beginning to intumesce

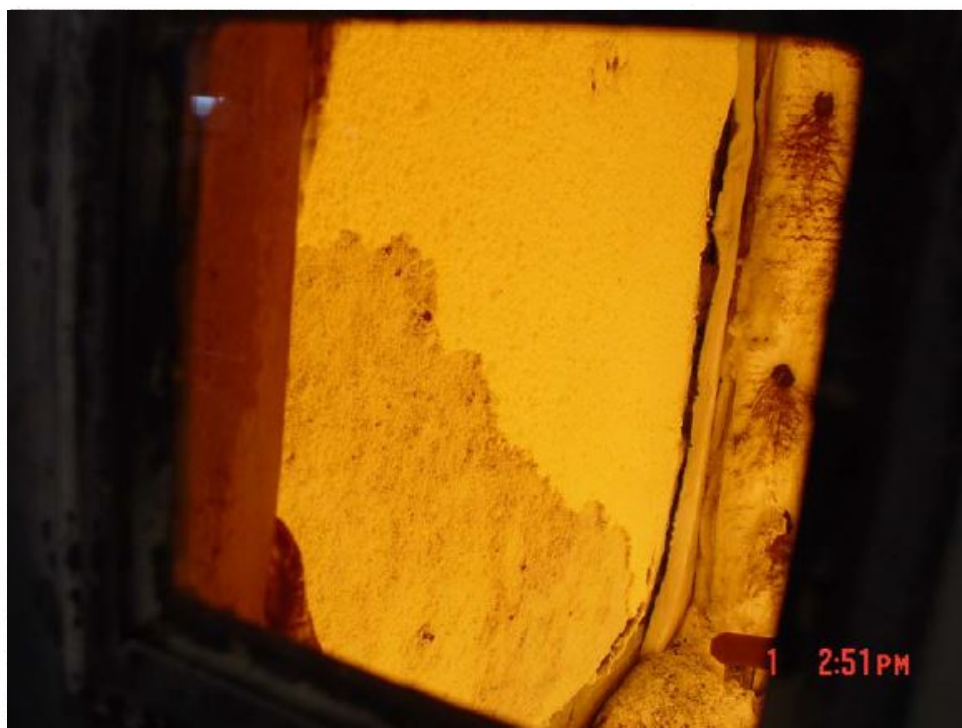
Photograph 4: Large pieces of intumescent falling from exposed face

0:30:00	Flaming on exposed surface at top right corner
0:34:04	Flames trying to attach along top edge
0:36:15	Exposed intumescent is white and fluffy, portions approx. 1/2" thick are falling from the sample

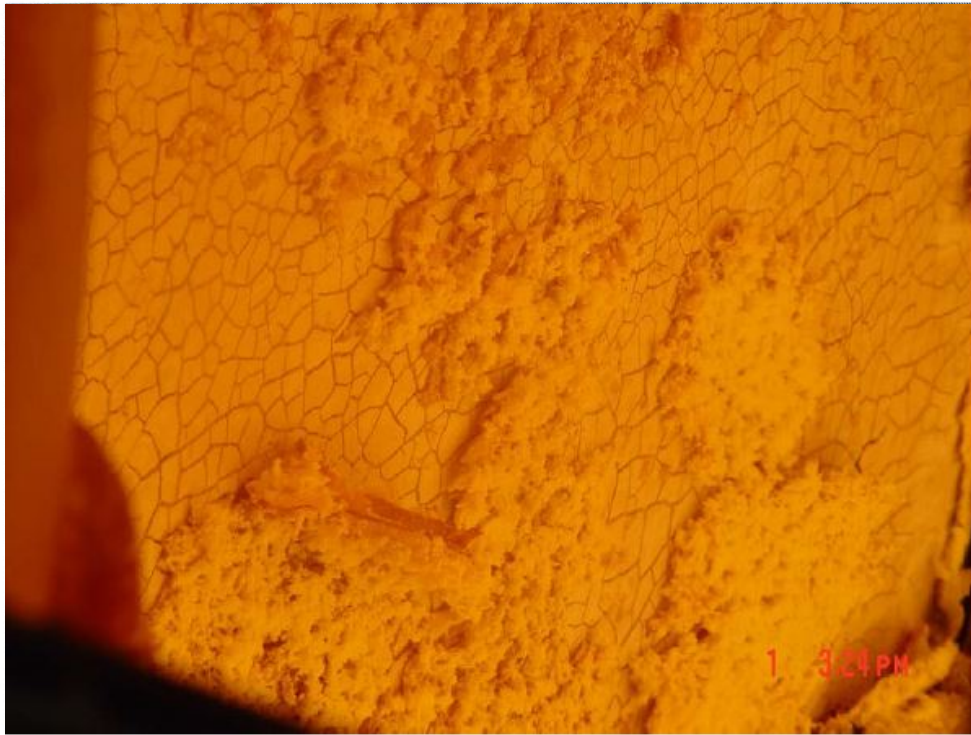
Photograph 5: Exposed intumescent continues to flake from sample

0:46:30	Two small areas seem bared to the substrate with no intumescent material left
0:50:35	Intumescent material continues to crumble and fall from the sample

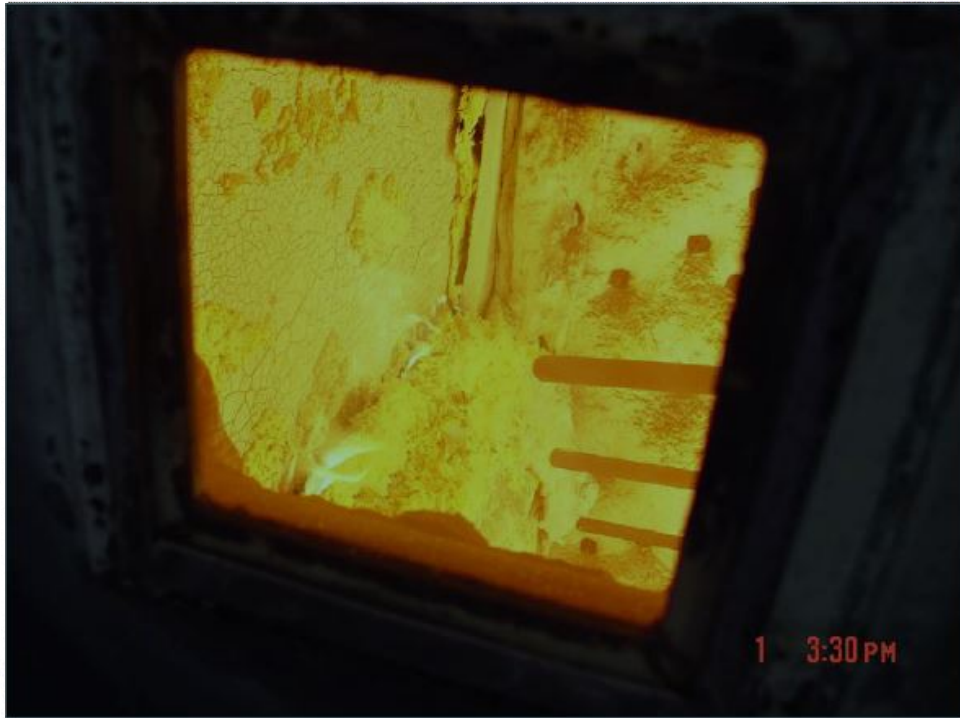
Photograph 6: Little intumescent remains and flames at bottom of sample near end of test

1:04:10	Gypsum surface is visible on most of the exposed side
1:07:19	Attached flames on exposed face on center/left side
1:10:59	Attached flames at bottom portion across sample

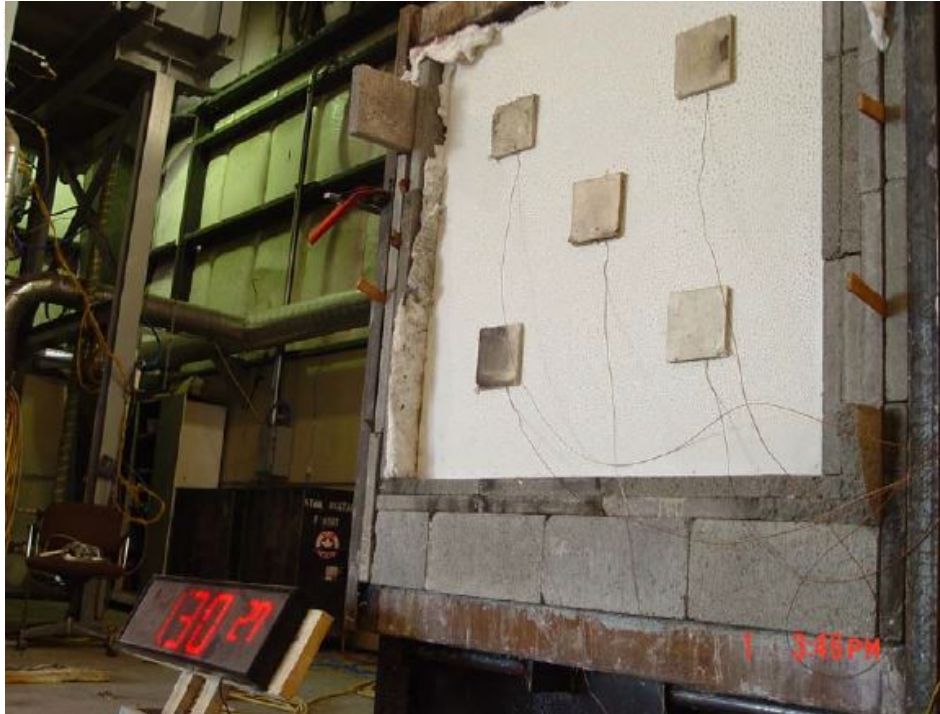
Photograph 7: Sample unexposed face near end of test

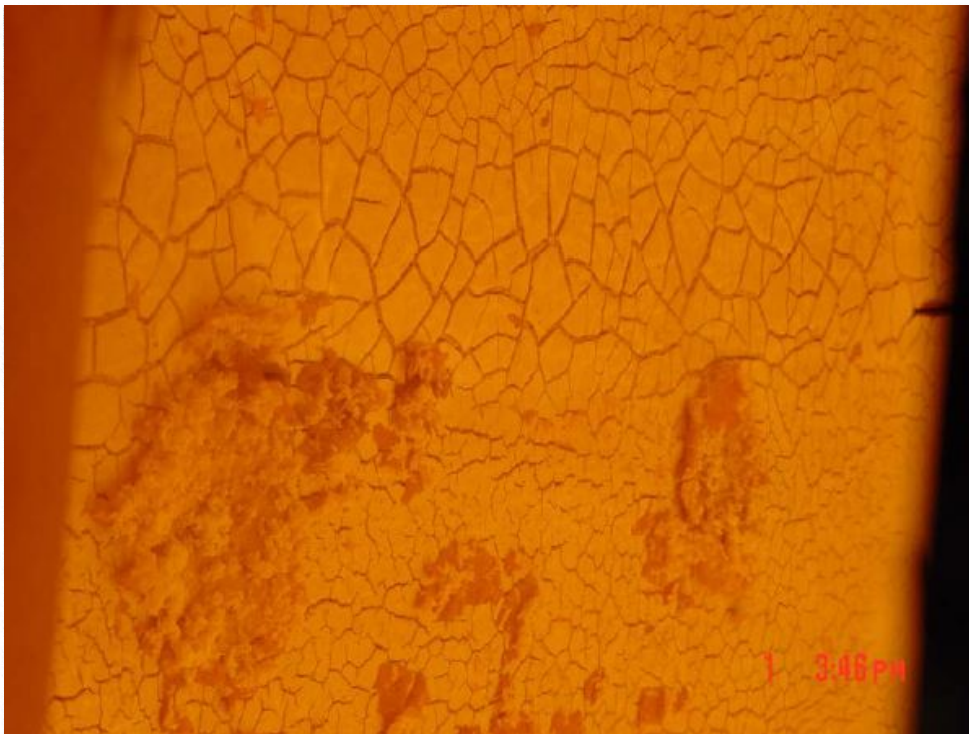
Photograph 8: Exposed face of sample near end of test

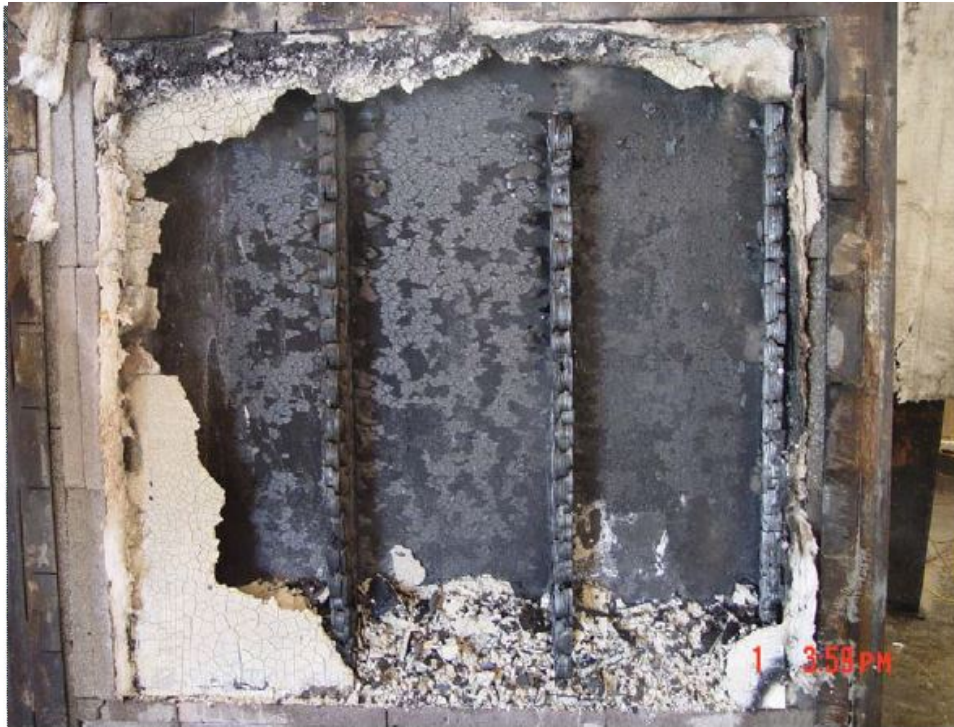
Photograph 9: Exposed sample face post-test

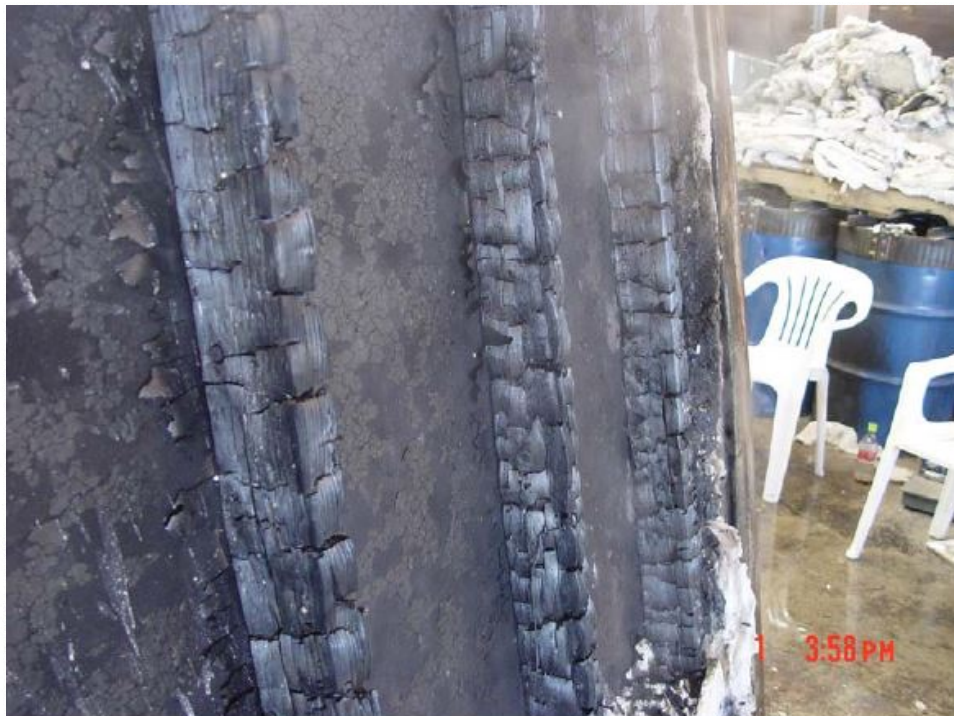
Photograph 10: Closer view of studs post-test

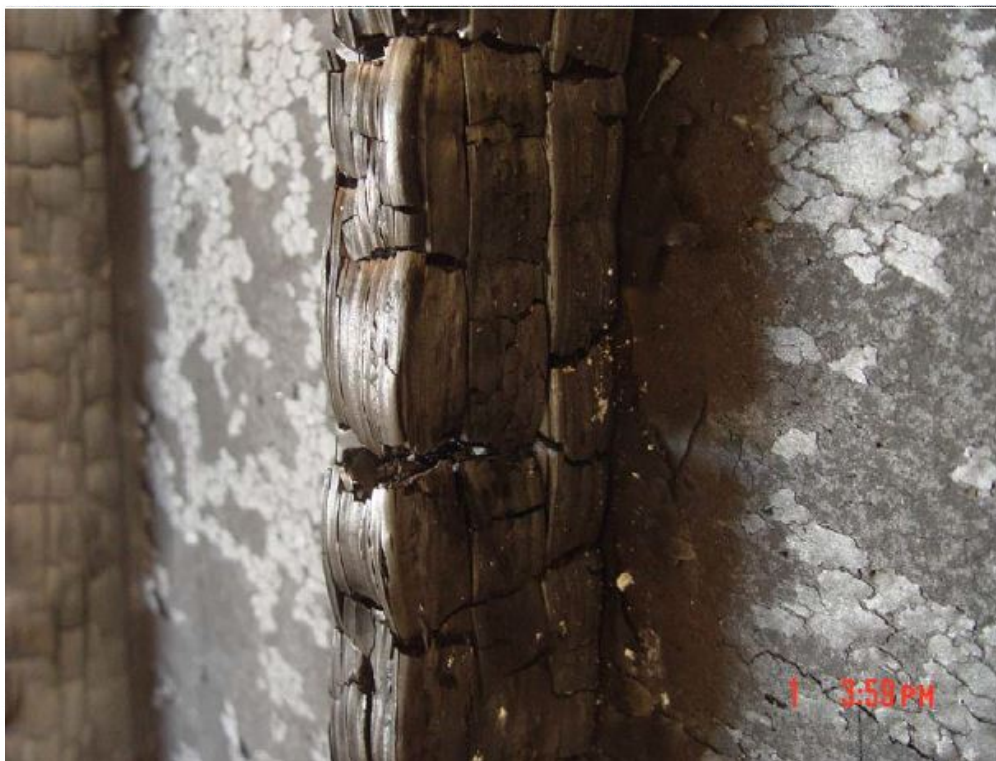
Photograph 11: Close-up of stud post-test
